FIBERGLASS MATERIAL
SPECIFICATION TEST SUPPORT

U.S. COAST GUARD
DEPARTMENT OF TRANSPORTATION

September 27, 1985

Battelle has conducted a preliminary investigation for the U.S. Coast Guard to establish an information baseline into possible causes for the blistering of gel coat laminates on boats.

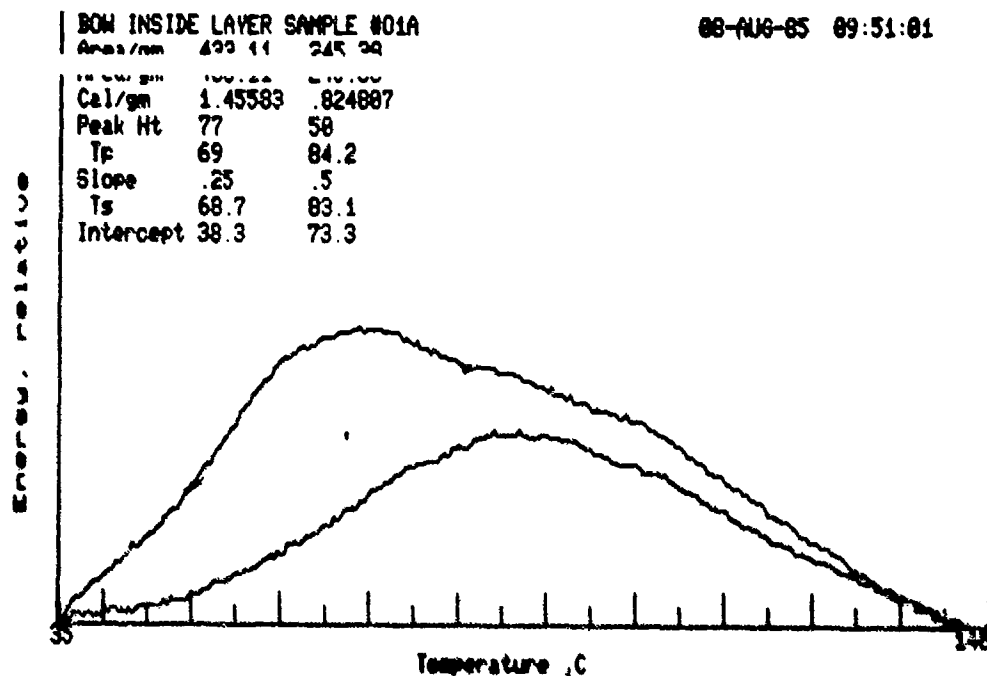
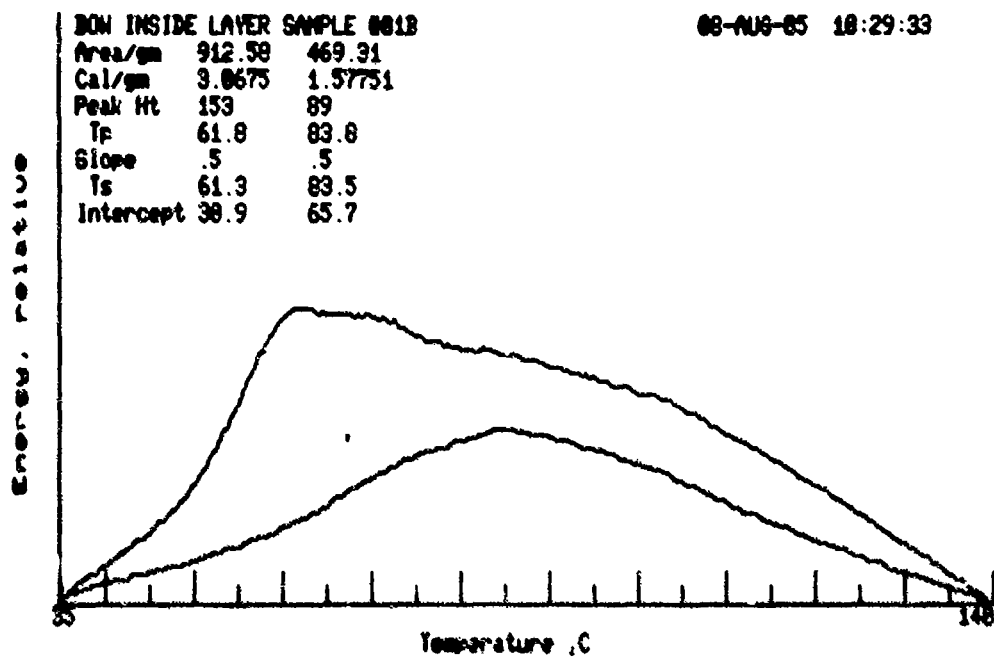
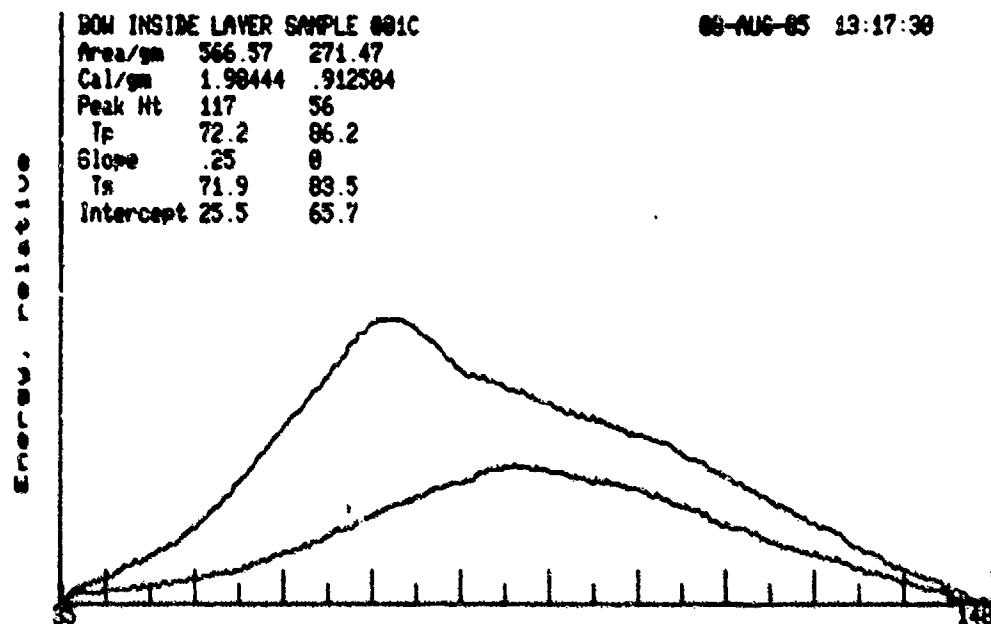
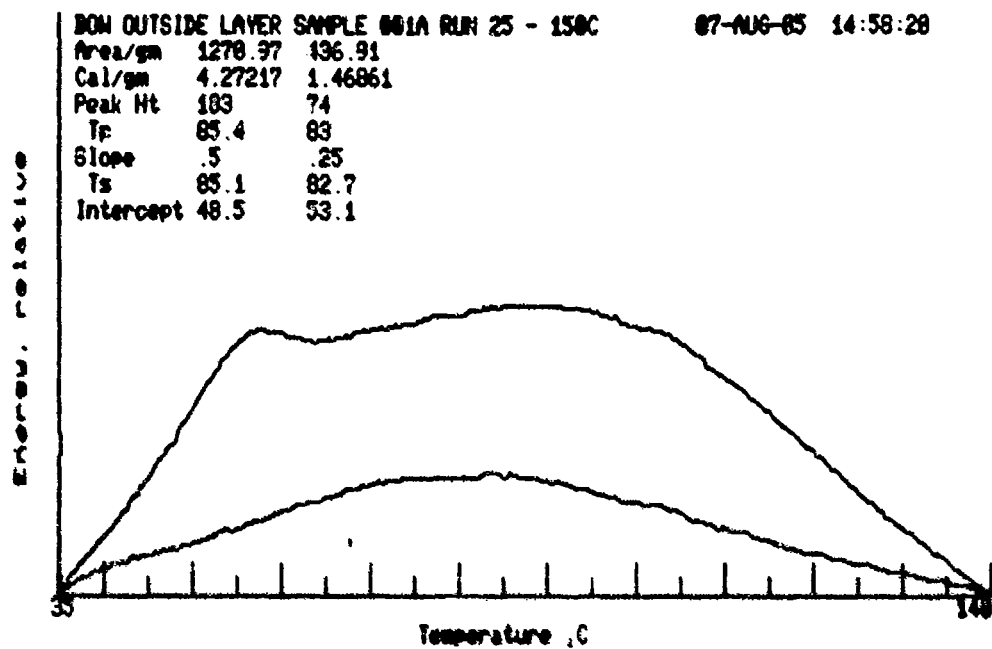
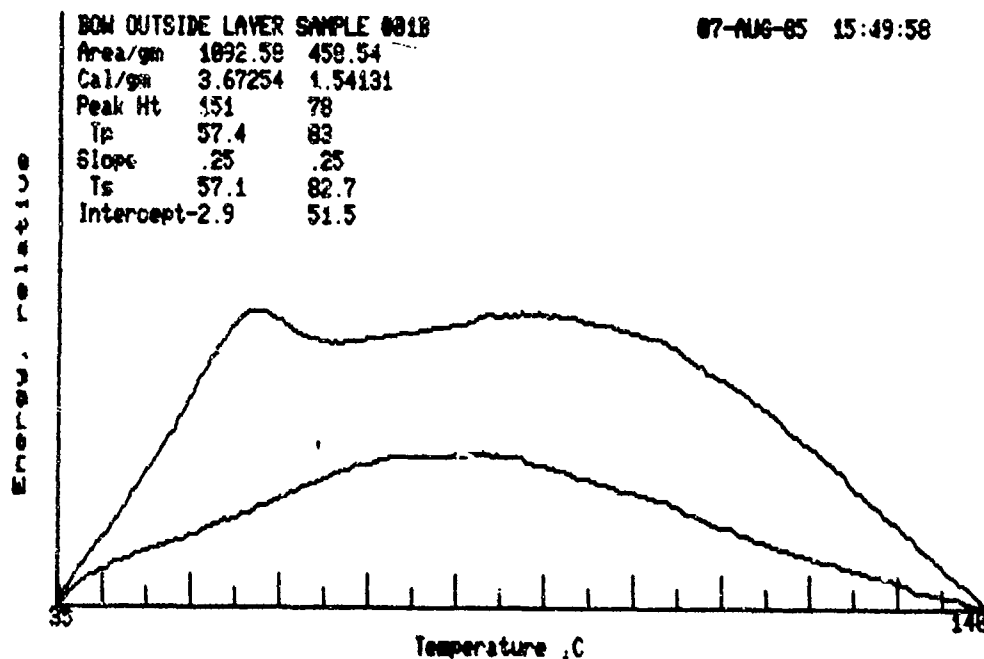
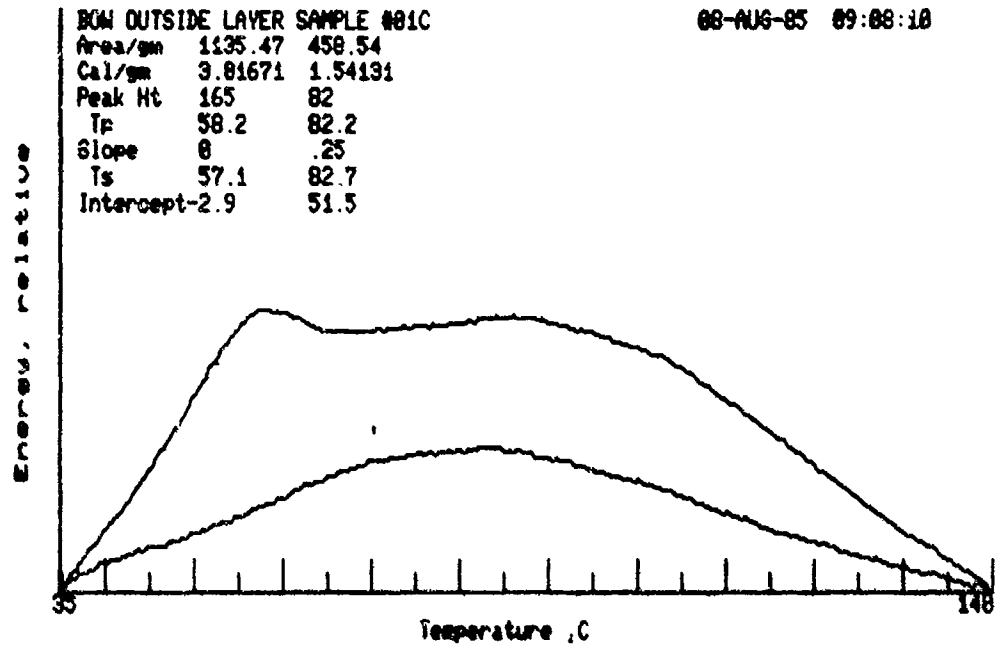
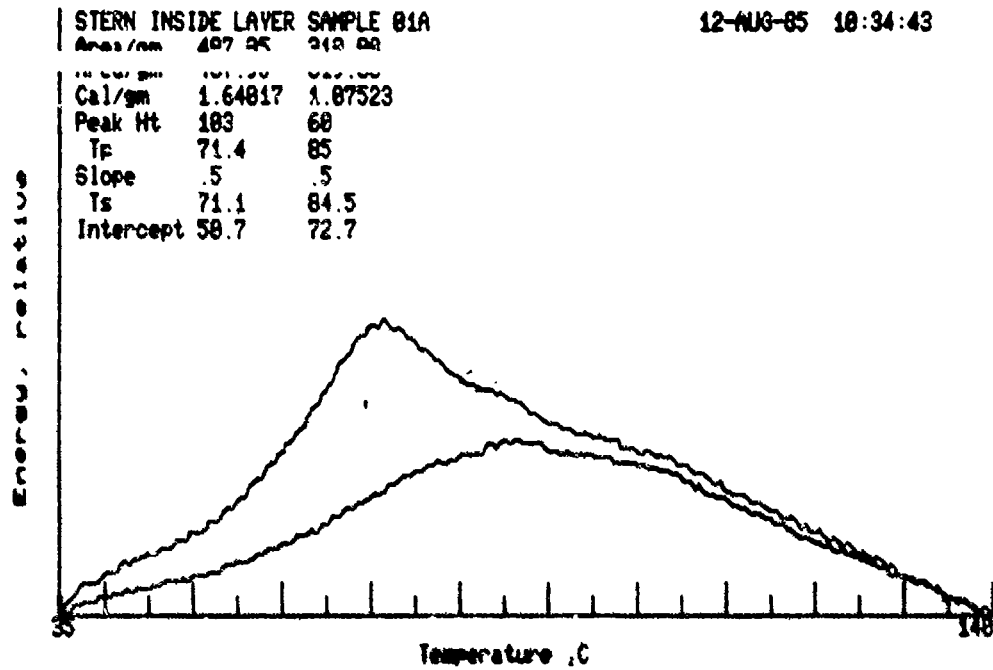
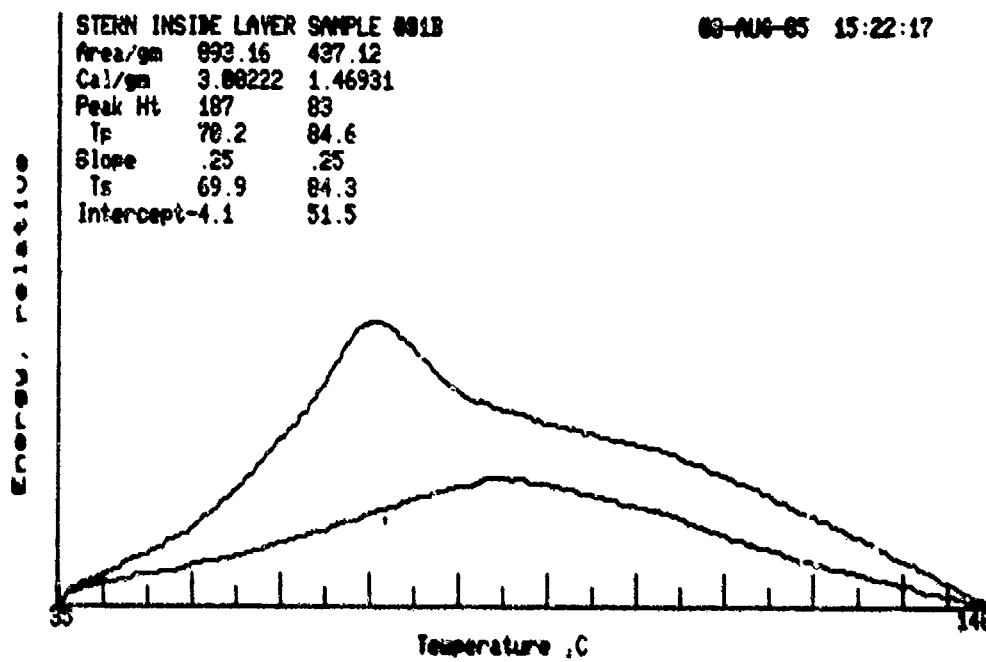
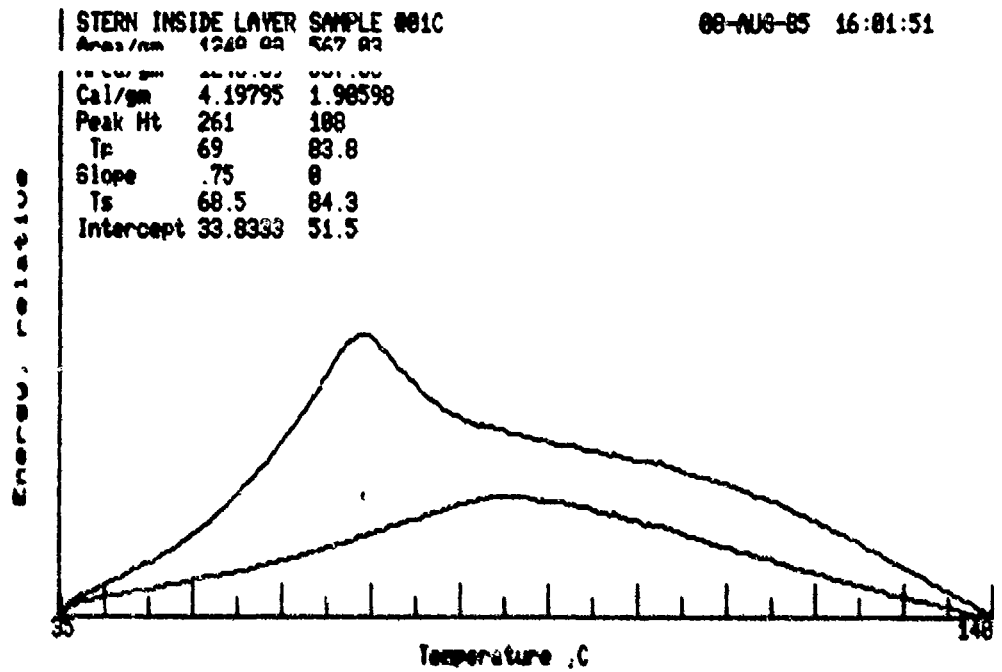
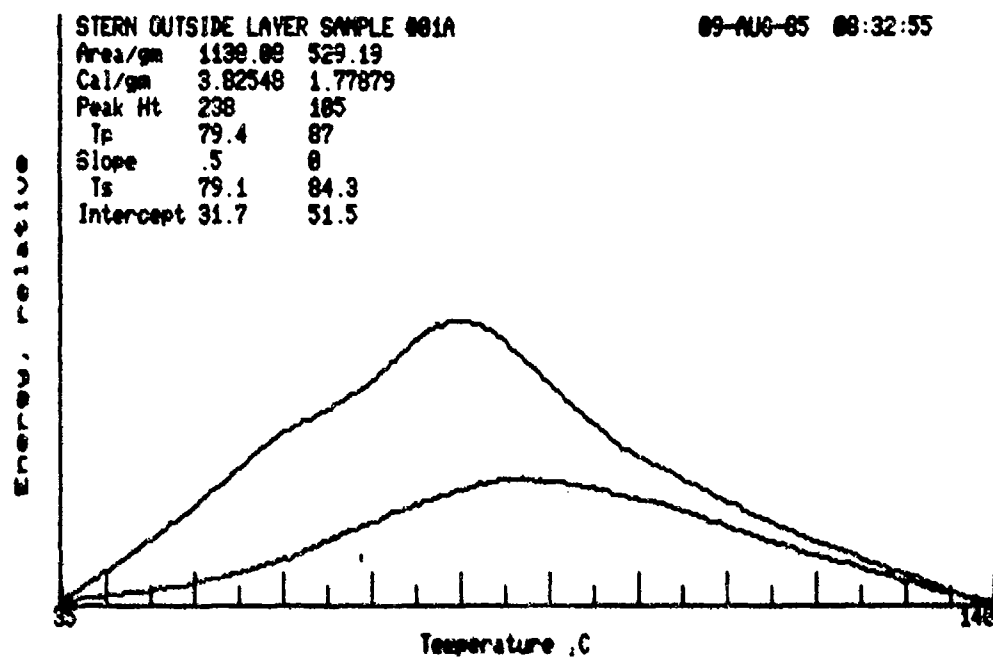
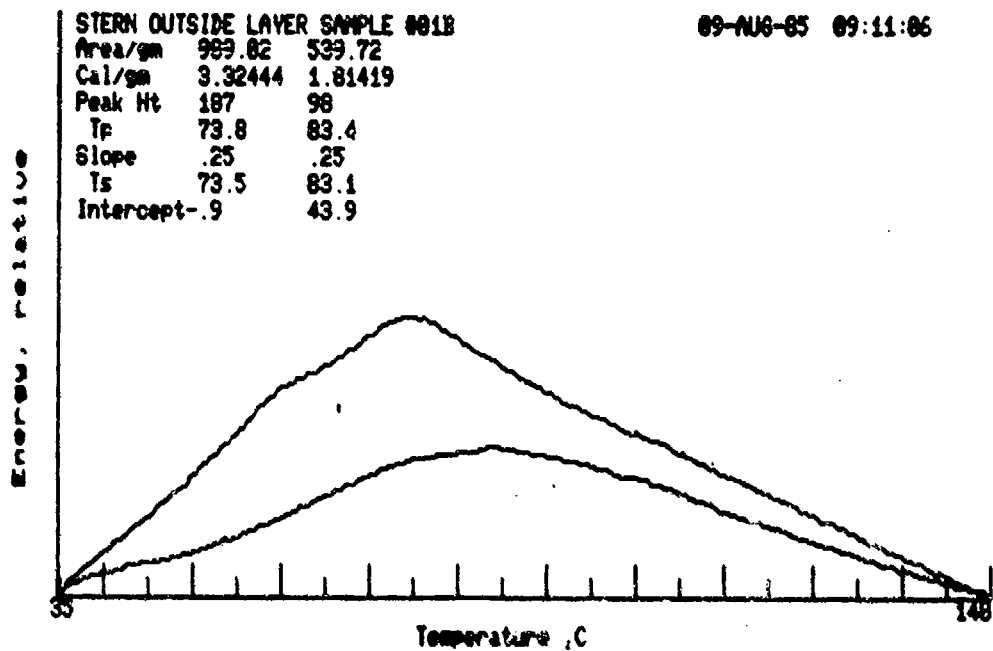
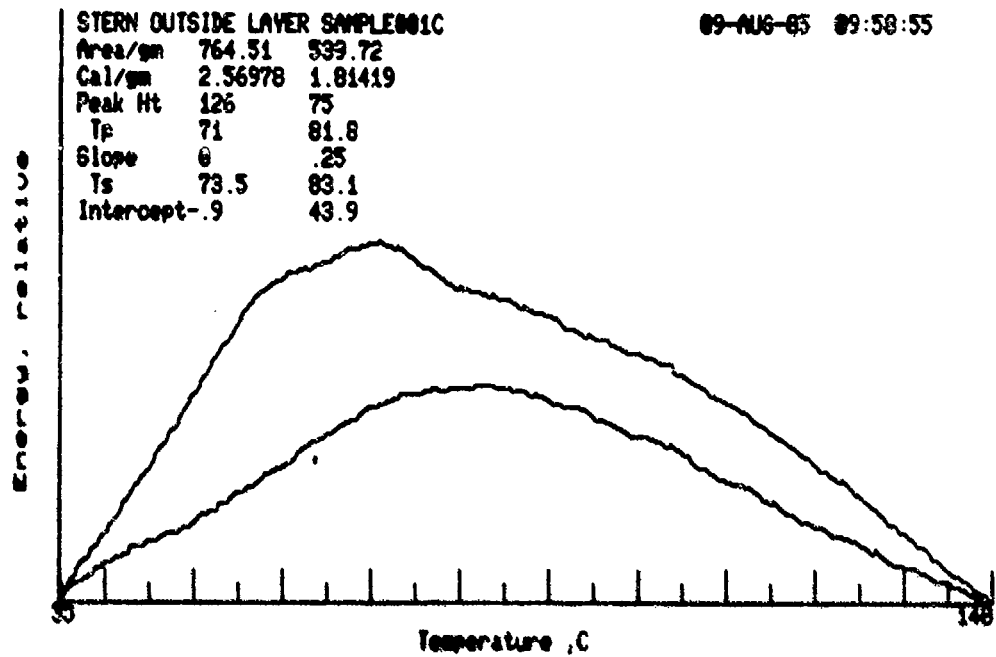
of the curing process, thus identifying the probable cause of blistering of these samples as undercuring.

- (1) Conduct a parametric cure grid to determine the critical factors associated with blistering. This would elucidate the factors and interrelationship of factors most responsible for deficient interlaminar cures. Factors should include all formulation variables, time, temperature, and humidity, processing variables, etc.

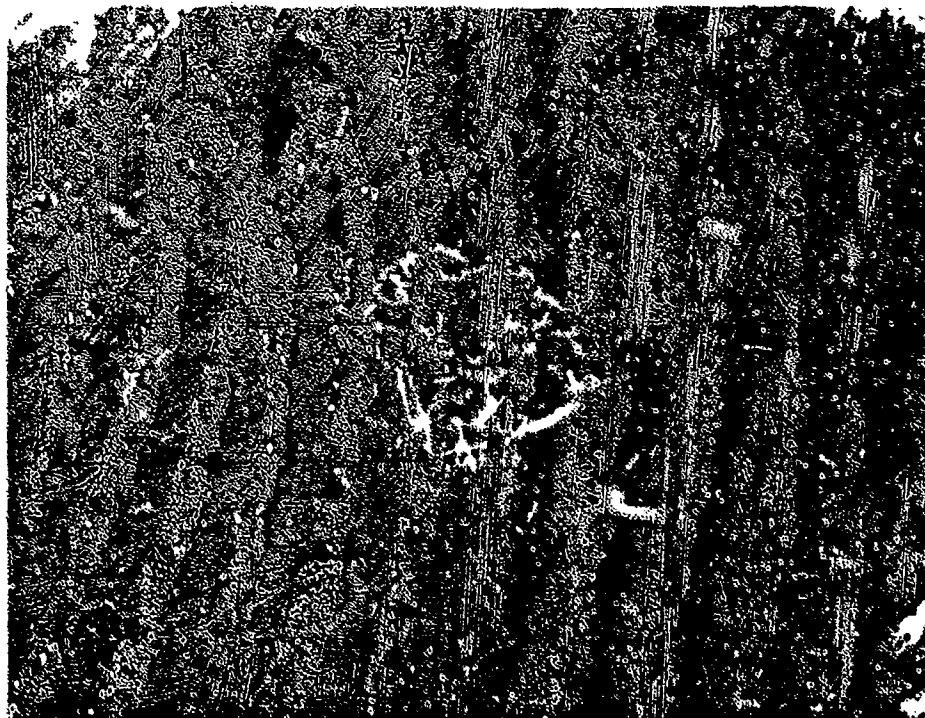
Figure 1. Typical blister between gel coat and back-up laminate. The
top of the blister has been cut away to show underlying glass fibers.
This laminate contained added glycol. The dark circular grid on the
edge of the blister is a 3 mm scale indicator.
